# WATERCOURSE ASSESSMENT

FOR THE PROPOSED EXPANSION OF WOODBURN SHOPPING CENTRE IN  
PIETERMARITZBURG, MSUNDUZI LOCAL MUNICIPALITY,  
UMGUNGUNDLOVU DISTRICT, KWA-ZULU NATAL

August 2022  
DRAFT REPORT

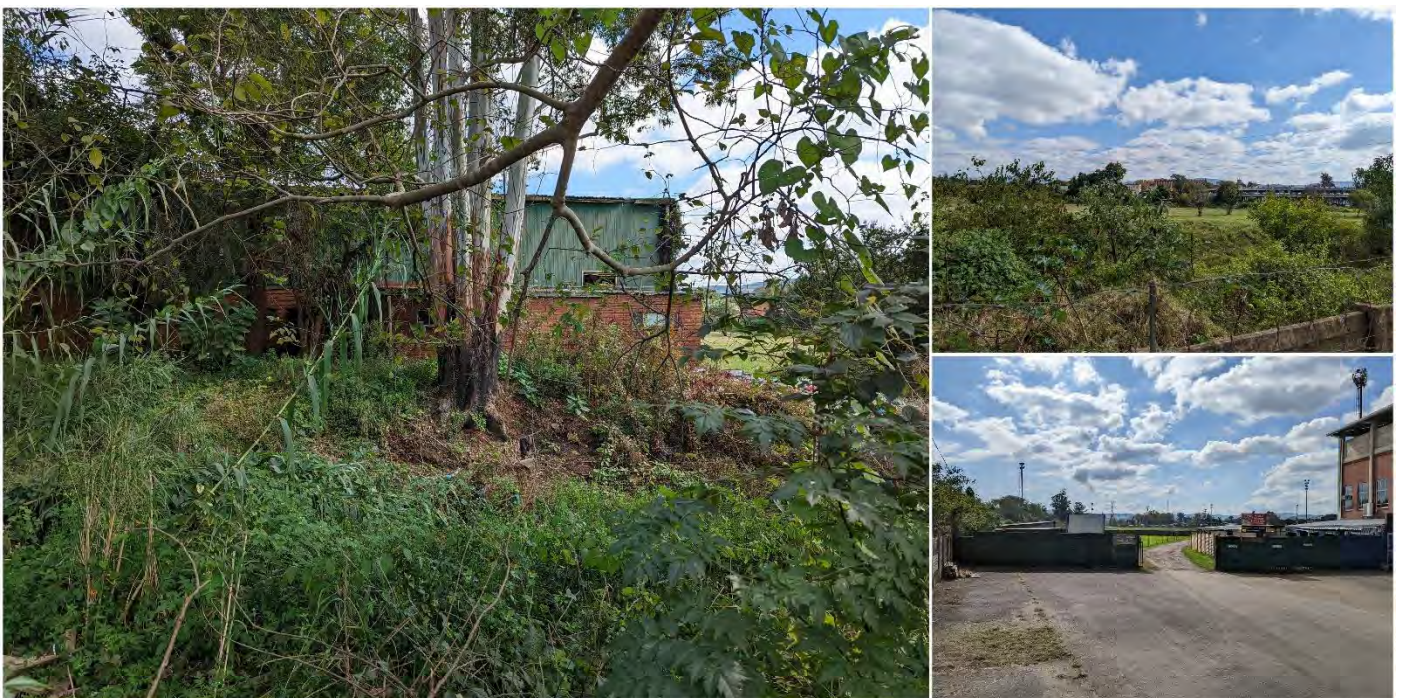
Figure 3 The site around Woodburn Shopping Centre

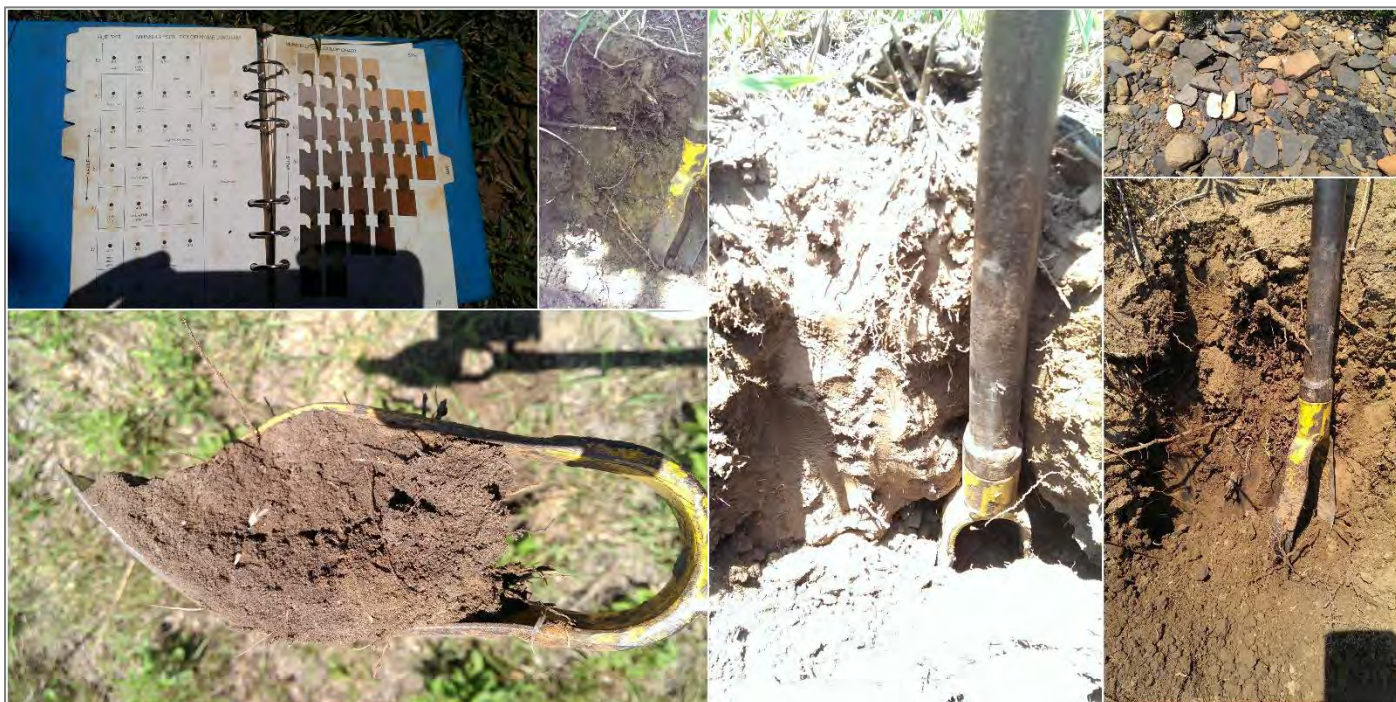
Figure 6 Soil sampling undertaken at the site

An example of the soil sampling approach is provided in Figure 6.

The area was extensively traversed, auger sample points were taken as required and the exact location of sample points logged using a Garmin GPSMAP 64. At each sampling point the soils were sampled at depths of 0-10 cm and 40-50 cm below surface. The soil value, hue and matrix chroma were recorded for each sample according to the Munsell Soil Colour Chart, and the degree of mottling and/or presence of concretions were recorded. Although the site was severely transformed, any vegetation of interest was noted for the assessments. If the author was not able to identify any potentially important species, a leaf and bark sample was taken for analysis using a key guide.

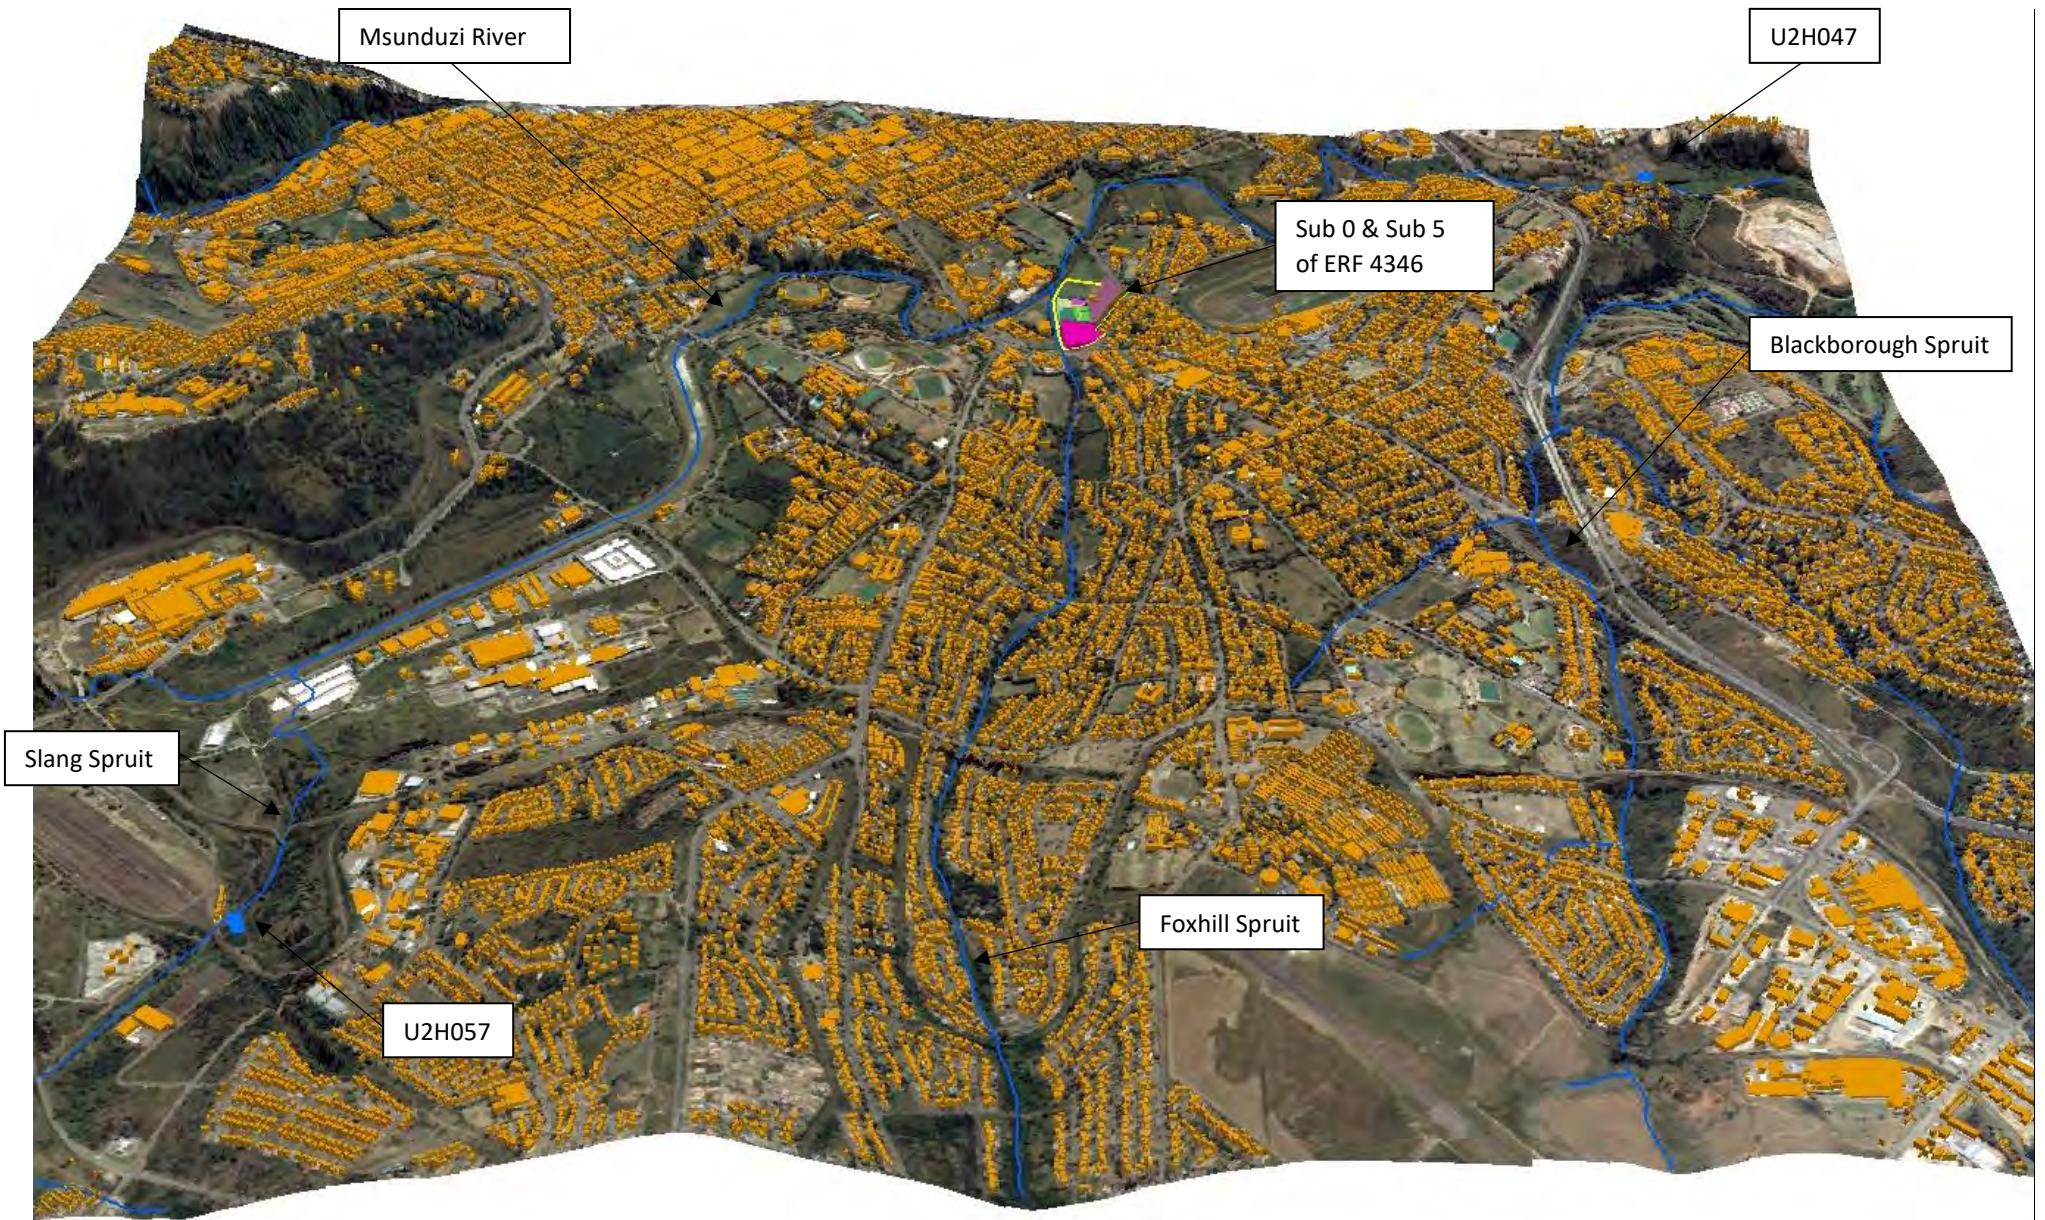
Figure 8 Exaggerated (x3) Digital Elevation Model (DEM) of the catchment surrounding Woodburn Shopping Centre

The site (Figure 8) is situated on a gentle to moderate slope, rising towards Pelham. In this setting, it is 101 meters at the closest point to the uMnsunduzi river. The majority of runoff from the site would flow directly towards the Foxhillspruit canal.

The geology of the site is characterised by Pietermaritzburg Ecce shale. The terrain, as identified through a desktop analysis had a gradient of 0.03 m/m and a slope of 1.5° between the upper lands and the river. The terrain was slightly uneven due to numerous buildings and roads. Some soil profiles were identified throughout the site. All of the non-wetland soils consisted of an Orthic A-horizon underlain by either a yellow a-pedal B-horizon (unconsolidated), lithocutanic material or ecce shale directly. Clovelly soils were the most commonly identified soils. Many of these points had transported material.

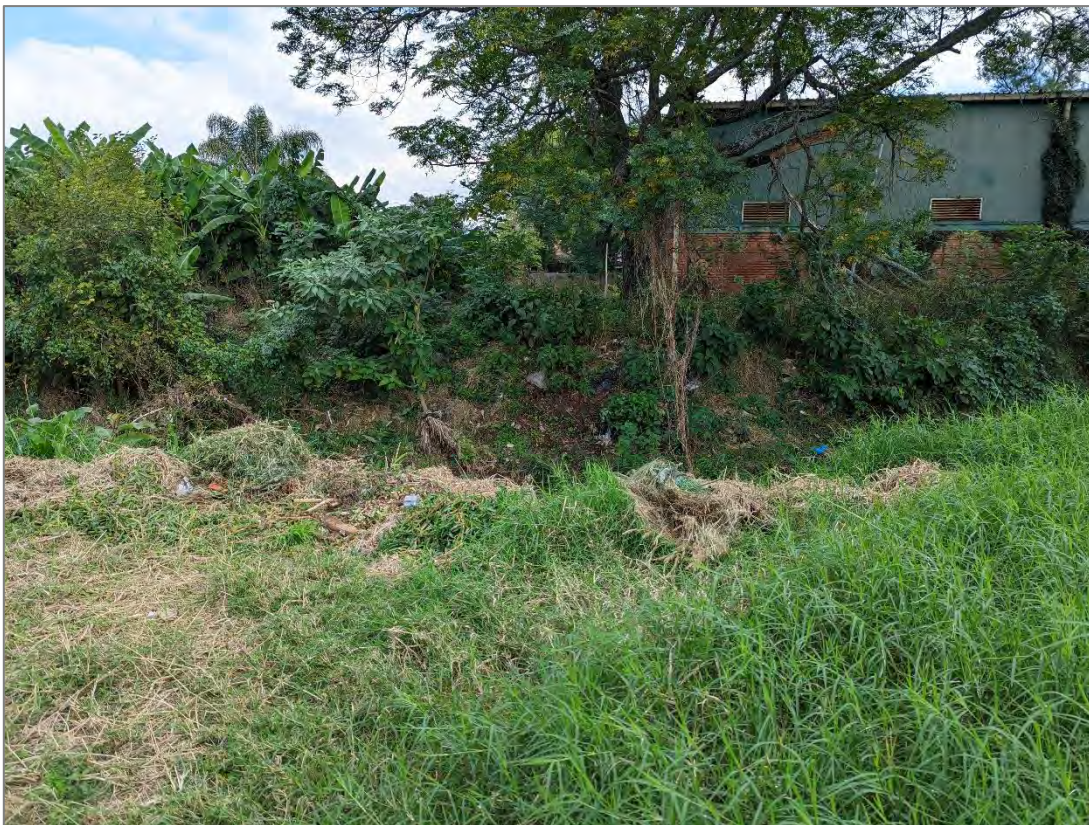
Figure 9 Typical vegetation around the site

The wetland/drainage system surrounding the Woodburn Shopping Centre site have been significantly historically modified.

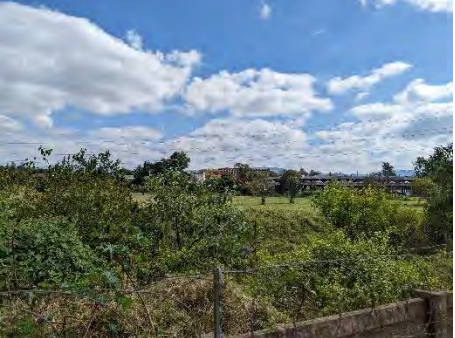
Feature	Wetland/Riparian/Artificial	Description & Vegetation (after Kotze, 1999)	Soil Characteristics	On-site images
RH	Riparian Habitat	Banks of the Msunduzi river. Dominated by tree and sedge species (mostly alien invasives). Veld is present on the flood plain side of the bank.	N/A

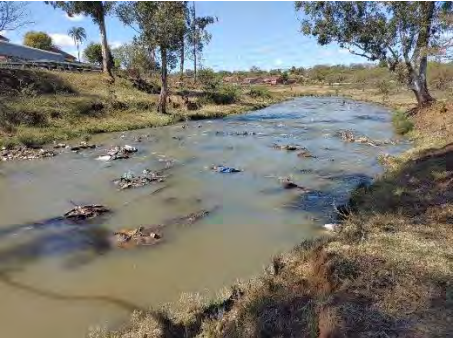
W	Watercourse (Msunduzi River)	A highly modified yet highly important river system that flows through Pietermaritzburg. Many households are dependent on this system.	No mottles Gley-5YR Value – 3 Chroma – 1 Dark Gray Depth sampled: 0-0.5m High Organic matter content in the upper layer

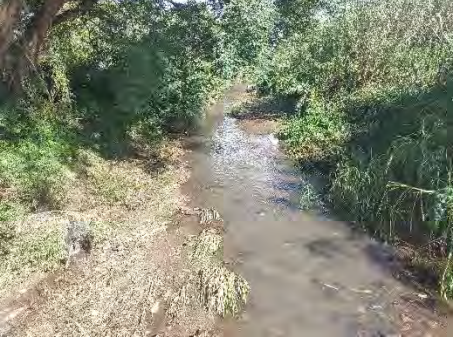
W	Watercourse (Foxhillspruit canal)	A highly modified canal system that flows through Pelham suburb. Many households grey water is discharged into this system.	No mottles Gley-5YR Value – 3 Chroma – 1 Dark Gray Depth sampled: 0-0.5m High Organic matter content in the upper layer
