REPORT TITLE:	REPORT ON THE RESULTS OF A GEOTECHNICAL INVESTIGATION CARRIED OUT AT 15 WOODHOUSE ROAD IN SCOTTSVILLE PIETERMARITZBURG FOR THE PROPOSED EXTENSIONS TO THE WOODBURN SHIPPNG CENTRE
REPORT NO:	GEO/1142/23/24
REPORT DATE:	1 MARCH 2023
REPORT STATUS:	FINAL REPORT
PREPARED FOR:	SHANBAR PROPERTY DEVELOPMENT ATT: MR ANDREW BARNES TEL: 033 – 344 1105 EMAIL: kavitha@barnesprop.co.za
PREPARED BY:	SHARDESH SEWLAL ENGINEERS 1 HUNTLEY PLACE WESTVILLE 3629 TEL: 031 266 7299 MOBILE: 082 3310 780 EMAIL: geotech@shardesh.co.za AUTHOR: SHARDESH SEWLAL (Pr. Sci. Nat.: 400082/00)

REPORT ON THE RESULTS OF A GEOTECHNICAL INVESTIGATION CARRIED OUT AT 15 WOODHOUSE ROAD IN SCOTTSVILLE PIETERMARITZBURG FOR THE PROPOSED EXTENSION TO THE WOODBURN SHOPPING CENTRE

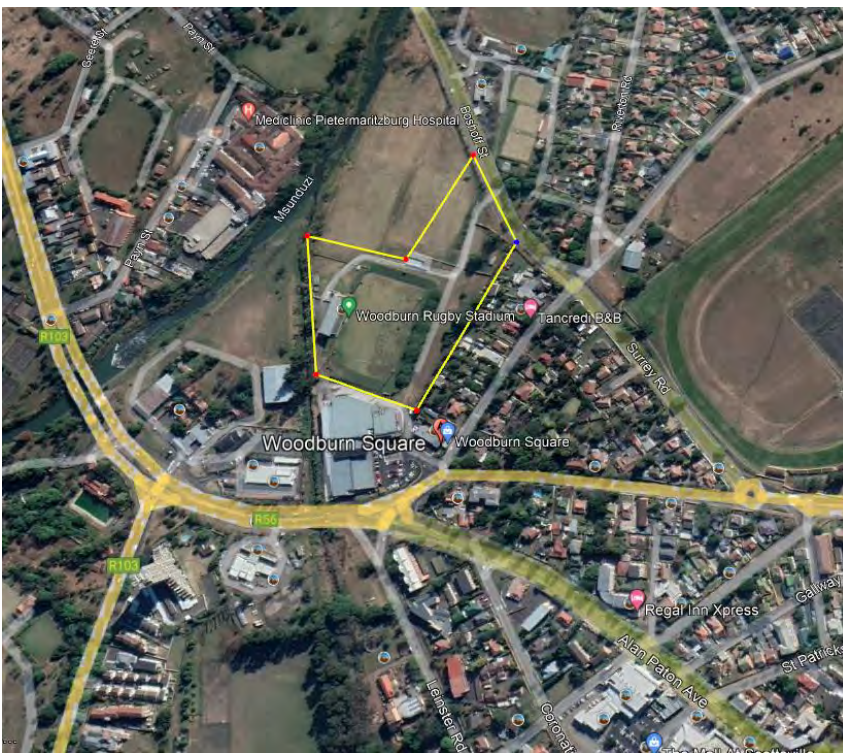
Plate 1: Locality of the site.

The Woodburn Shopping Centre is located at 15 Woodhouse Road in Scottsville Pietermaritzburg. The area proposed for the extension is situated north of the existing shopping centre and spans over the existing Woodburn Rugby Stadium.

The Woodburn Rugby Stadium is bound to the north by practice fields, to the east by residential dwellings and commercial properties, and to the west by an open space.

No natural drainage features were identified on the site itself. The Msunduzi River is located approximately 150m north west of the site.

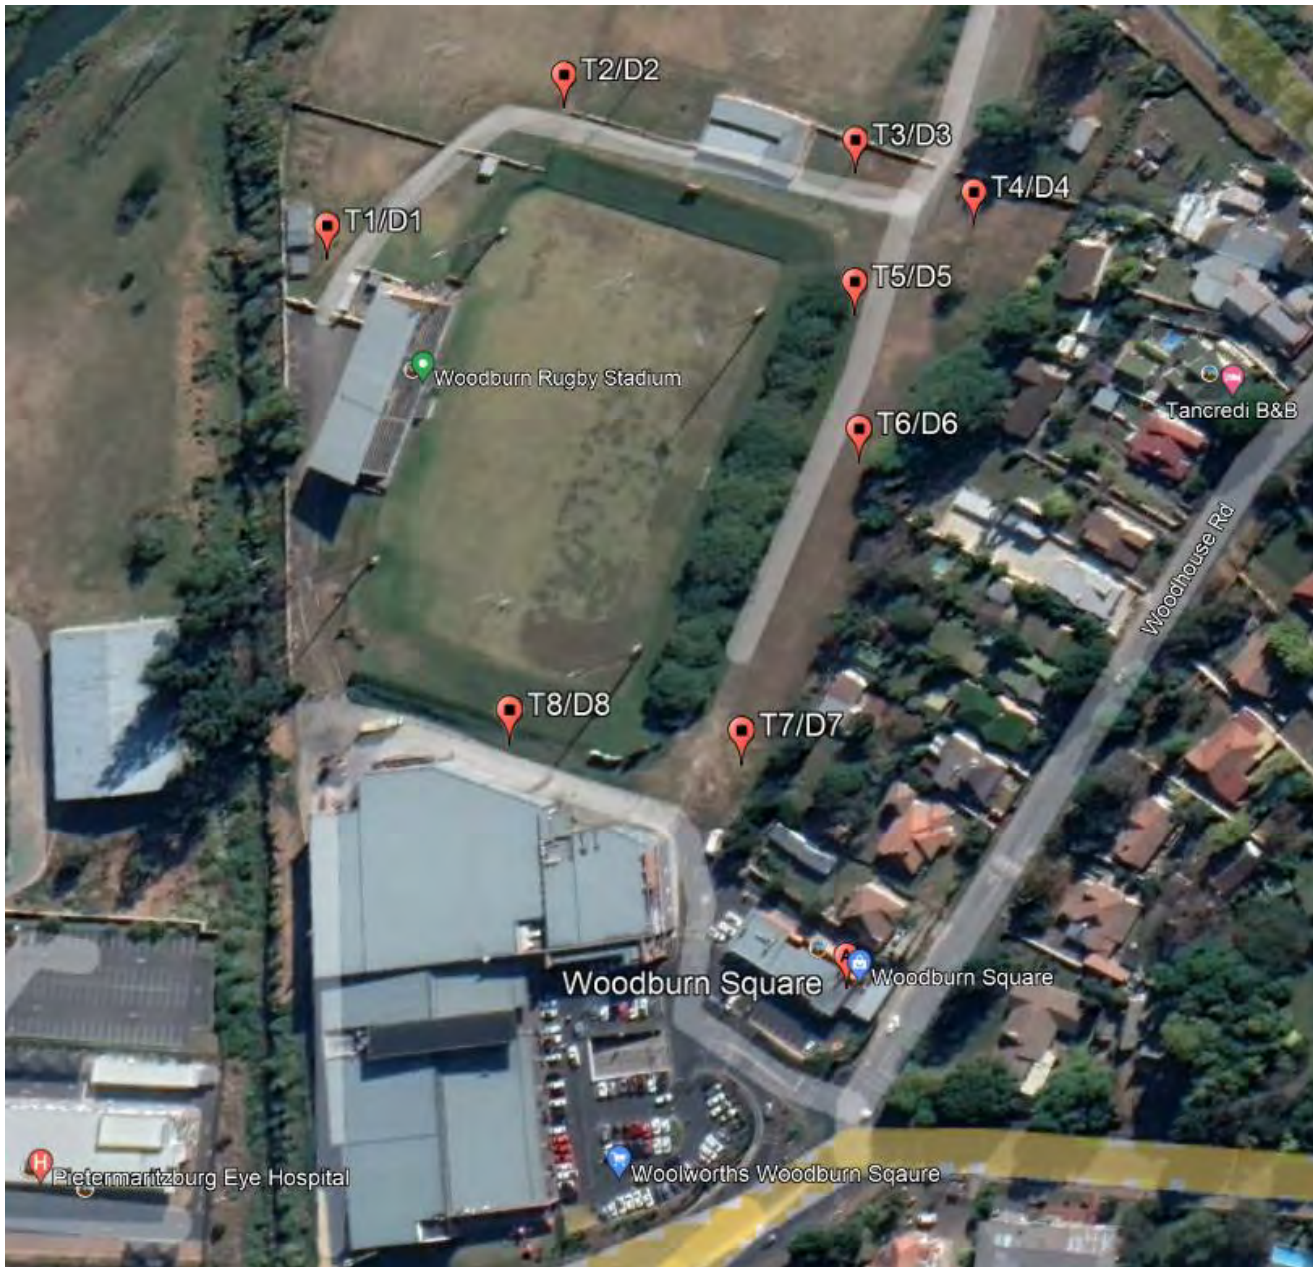
PLAN SHOWING THE APPROXIMATE POSITIONS OF THE TEST PITS
AND DYNAMIC CONE PENETROMETER (DPL) TESTS

The positions of the test pits and DCP tests are shown on the site plan attached in Appendix A. The test pit logs are given in Appendix B and the DPL test results are given in Appendix C.

T: Test Pits
 D: DPL Tests
