WATERCOURSE ASSESSMENT

FOR THE PROPOSED EXPANSION OF WOODBURN SHOPPING CENTRE IN
PIETERMARITZBURG, MSUNDUZI LOCAL MUNICIPALITY,
UMGUNGUNDLOVU DISTRICT, KWA-ZULU NATAL

August 2022
DRAFT REPORT

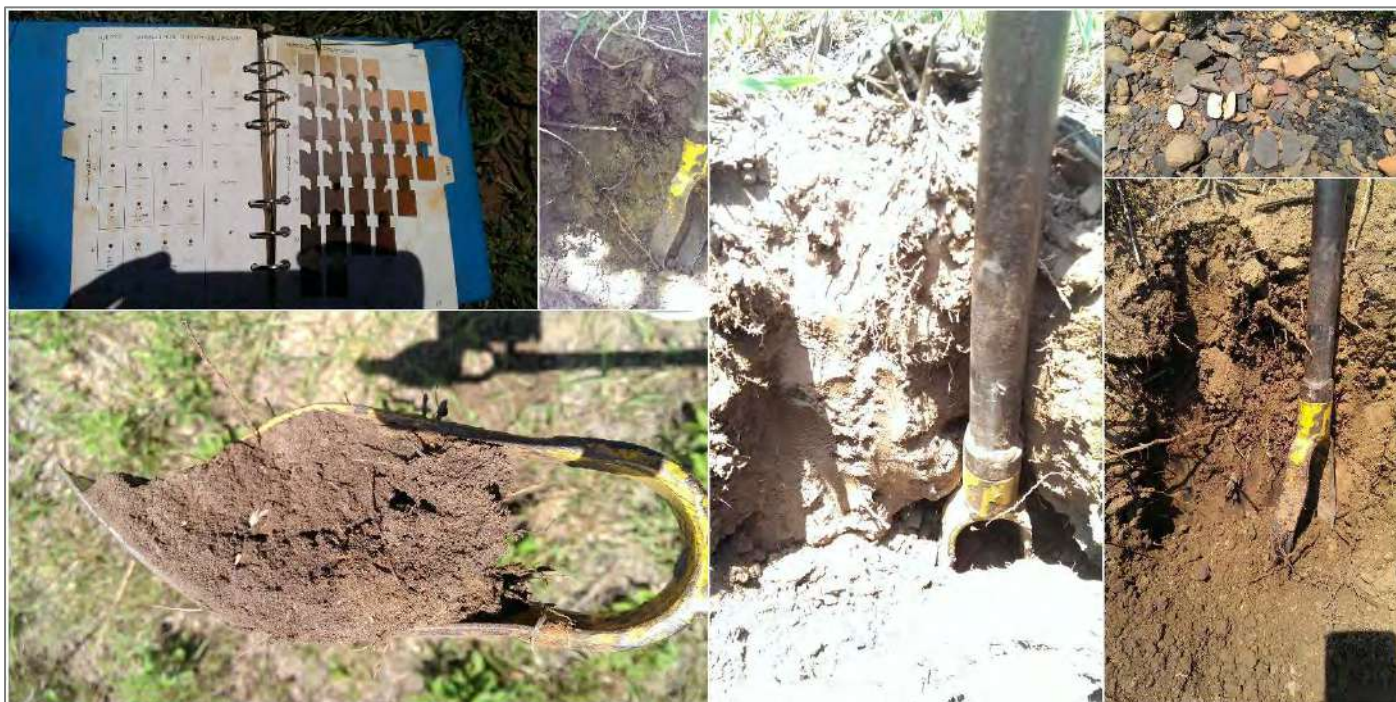
Figure 6 Soil sampling undertaken at the site

An example of the soil sampling approach is provided in Figure 6.

The area was extensively traversed, auger sample points were taken as required and the exact location of sample points logged using a Garmin GPSMAP 64. At each sampling point the soils were sampled at depths of 0-10 cm and 40-50 cm below surface. The soil value, hue and matrix chroma were recorded for each sample according to the Munsell Soil Colour Chart, and the degree of mottling and/or presence of concretions were recorded. Although the site was severely transformed, any vegetation of interest was noted for the assessments. If the author was not able to identify any potentially important species, a leaf and bark sample was taken for analysis using a key guide.

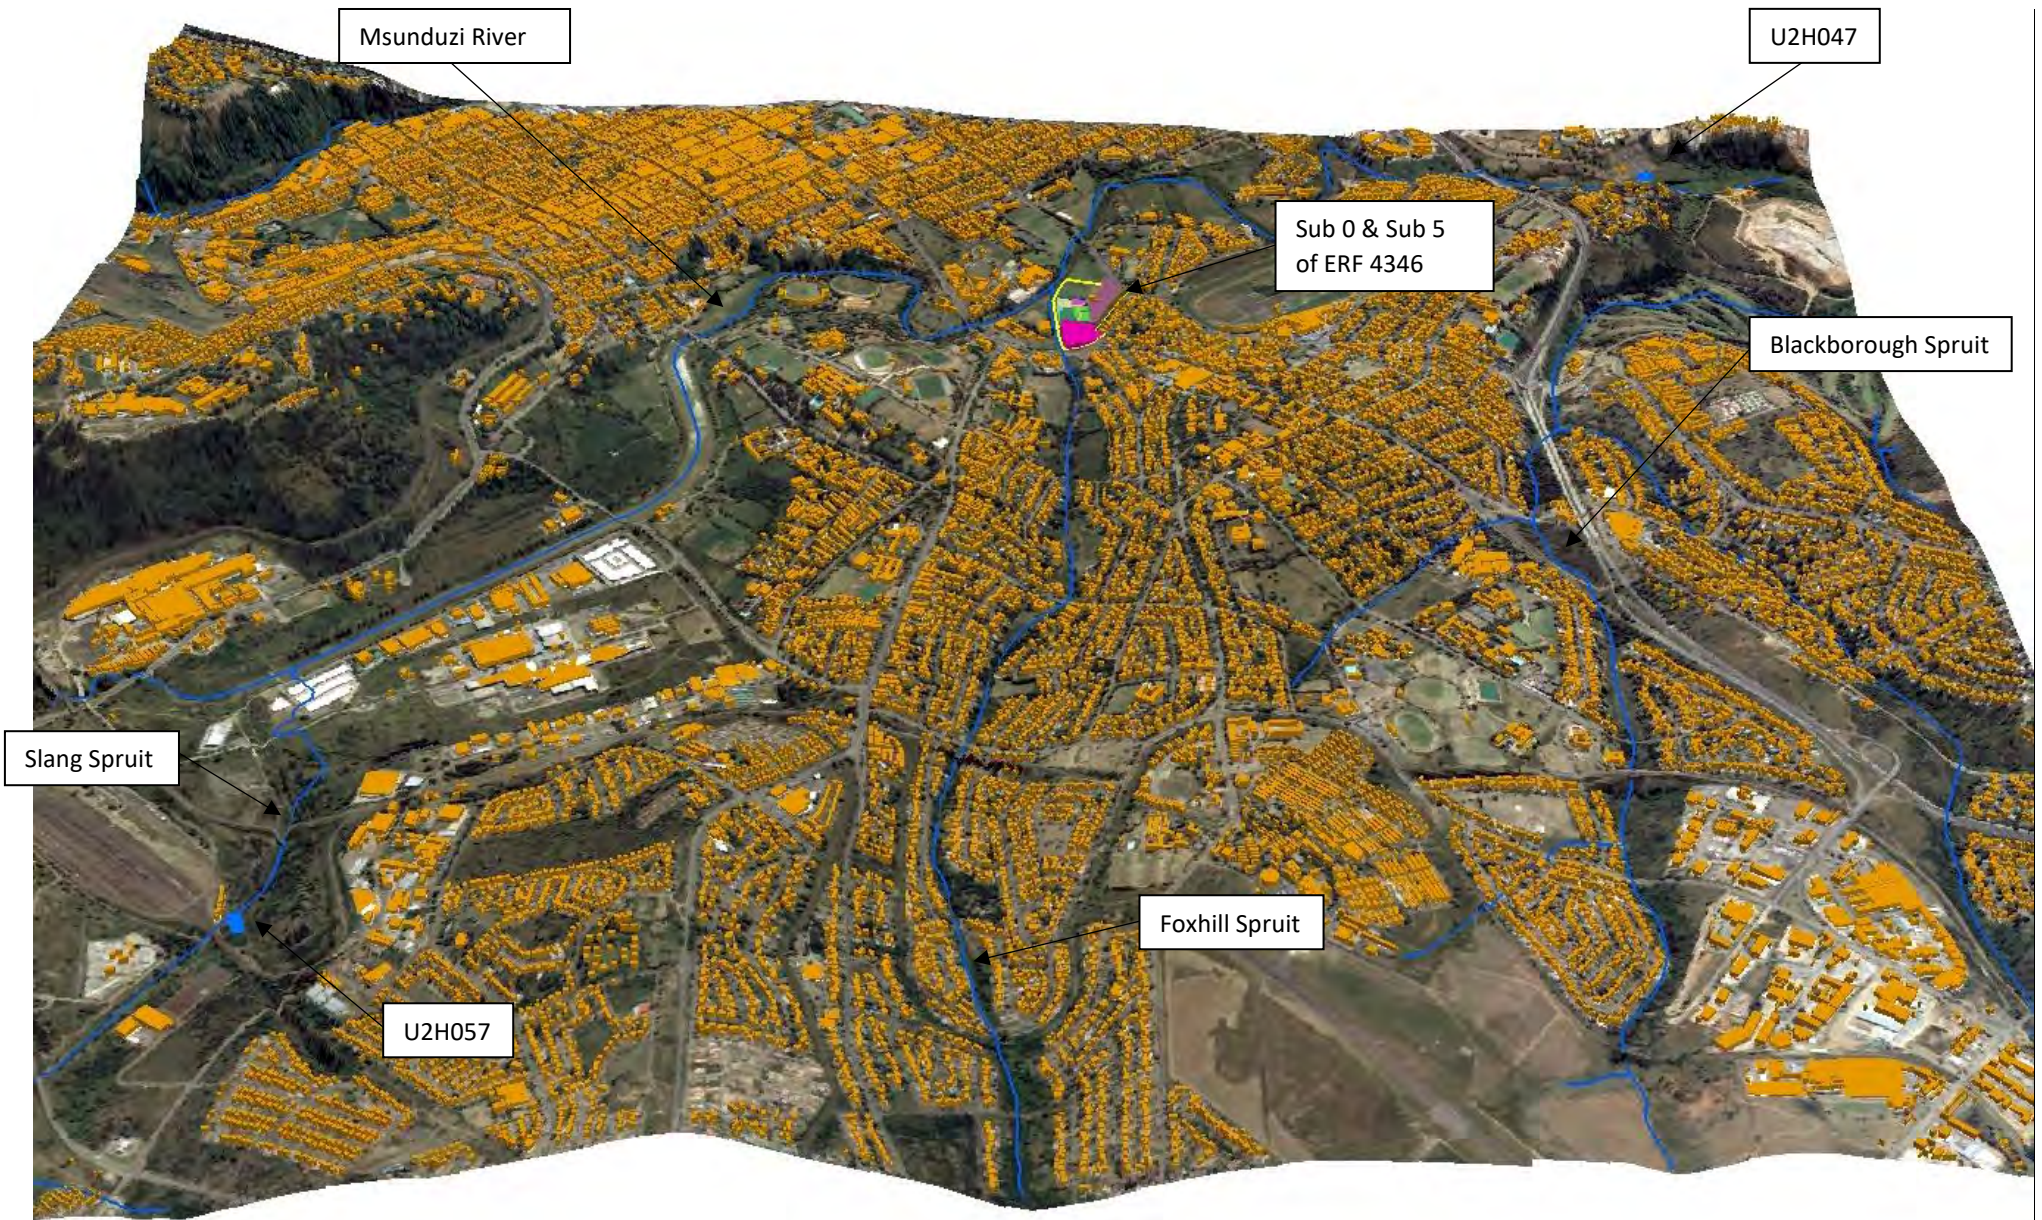
Figure 8 Exaggerated (x3) Digital Elevation Model (DEM) of the catchment surrounding Woodburn Shopping Centre

The site (Figure 8) is situated on a gentle to moderate slope, rising towards Pelham. In this setting, it is 101 meters at the closest point to the uMnsunduzi river. The majority of runoff from the site would flow directly towards the Foxhillspruit canal.

The geology of the site is characterised by Pietermaritzburg Ecce shale. The terrain, as identified through a desktop analysis had a gradient of 0.03 m/m and a slope of 1.5° between the upper lands and the river. The terrain was slightly uneven due to numerous buildings and roads. Some soil profiles were identified throughout the site. All of the non-wetland soils consisted of an Orthic A-horizon underlain by either a yellow a-pedal B-horizon (unconsolidated), lithocutanic material or ecce shale directly. Clovelly soils were the most commonly identified soils. Many of these points had transported material.

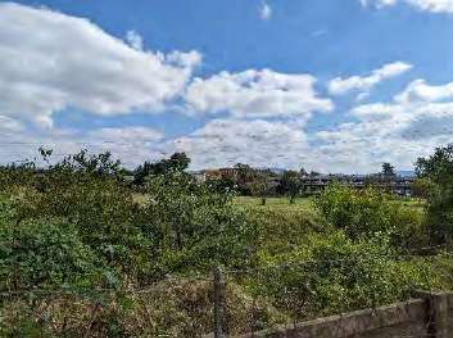
W	Watercourse (Msunduzi River)	A highly modified yet highly important river system that flows through Pietermaritzburg. Many households are dependent on this system.	No mottles Gley-5YR Value – 3 Chroma – 1 Dark Gray Depth sampled: 0-0.5m High Organic matter content in the upper layer

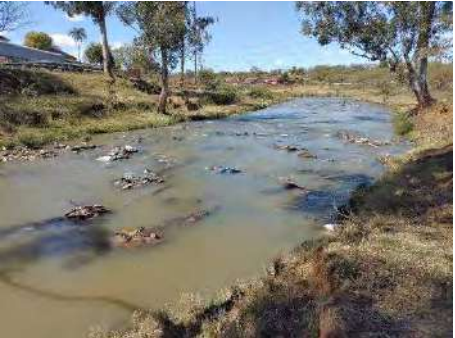
W	Watercourse (Foxhillspruit canal)	A highly modified canal system that flows through Pelham suburb. Many households grey water is discharged into this system.	No mottles Gley-5YR Value – 3 Chroma – 1 Dark Gray Depth sampled: 0-0.5m High Organic matter content in the upper layer
