Hydrogeological Assessment for the proposed dam and slurry irrigation at the Dartford Farming Trust in Underberg, KwaZulu-Natal

Document Number: HG01-00-GEN-2023.12.28-r1-REP-EMA0011

Hunts Green Consulting (Pty) Ltd

January 2024

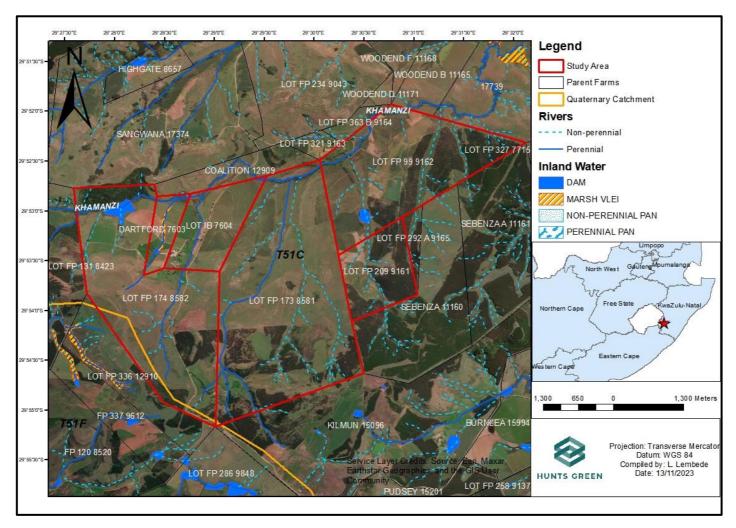
Figure 1-1: Local Setting of the Project Area

The dam, irrigation fields, sludge dams and 500m regulated area are located on 4 farm portions, within the Underberg area, Dr Nkosazana Dlamini-Zuma Local Municipality, Kwazulu-Natal (Figure 1-1) namely:

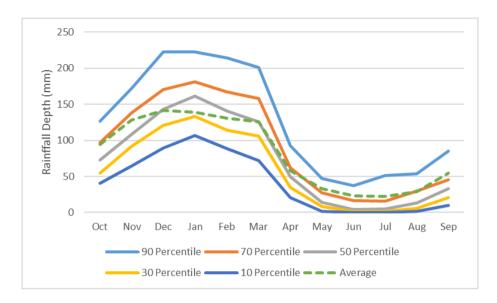
Figure 3-1: Monthly Rainfall Distribution for Quaternary Catchment T51C

Figure 3-1 shows the historical distribution of rainfall, with the 90th percentile of monthly rainfall representing extreme wet conditions and the 10th percentile represents drought events. Rainfall will normally vary between the 30th and 70th percentiles, which indicate steady summer rainfall over a 6-month period and a shorter, relatively dry winter period.

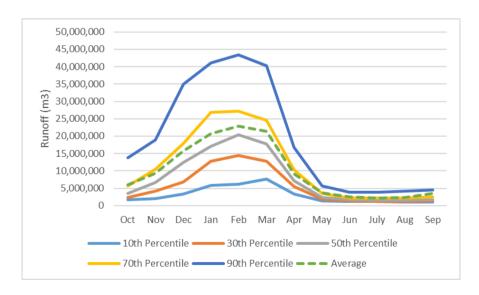
Figure 3-2: Naturalized Flow within Quaternary Catchment T51C

The naturalized runoff for quaternary catchment T51C and for the delineated upstream runoff contributing catchment for the study area is approximately 120 Mm³/annum and 10M m³/annum, respectively (Bailey & Pitman, 2015). The quaternary catchment experiences wet months between November to April, followed by drier months between May to October (Figure 3-2). The driest month is July, with an average of 2.1 Mm³, while the wettest month is February, with an average runoff of 22.9 Mm³.

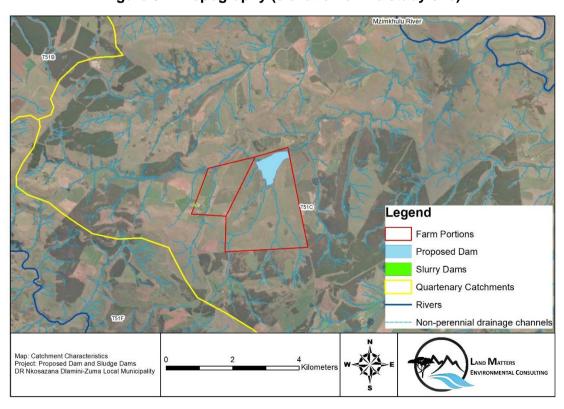
Figure 3-5: Catchment characterisitics of the study site

The study site is located within the Pongola-Mtamvuna Water Management Area (WMA) and more specifically in the T51C quaternary catchment (Figure 3-5). The main river which flows within the quartenary catchment is the Mzimkhulu River which flows approximately 4.2 km to the east of the study site. A number of smaller non-perennial watercourses flow within the study site (Figure 3-5).

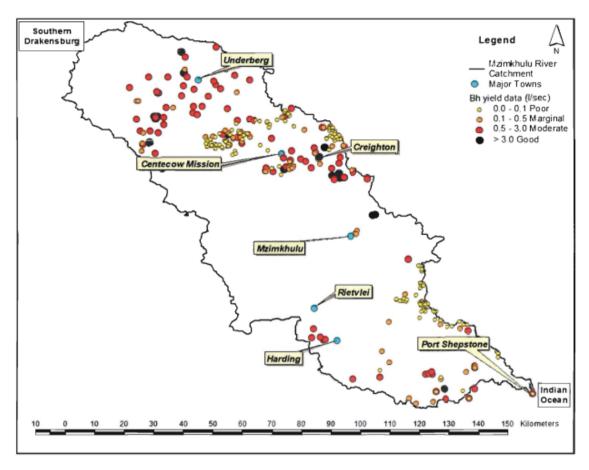
Figure 4-1: Regional Borehole Yied (DWS, 2011)

Yields of 3ℓ /s (greater than 10 000 ℓ /hr) are not uncommon where large scale fracturing/faulting provide conduits for groundwater movement. Boreholes located in and around Underberg indicate yield characteristics in the range 0.1 to >3 ℓ /s. More precisely, the yields range between 0.5-3 ℓ /s with selected boreholes north-west where yields between 0.1->3 ℓ /s are characterised (Figure 4-1).

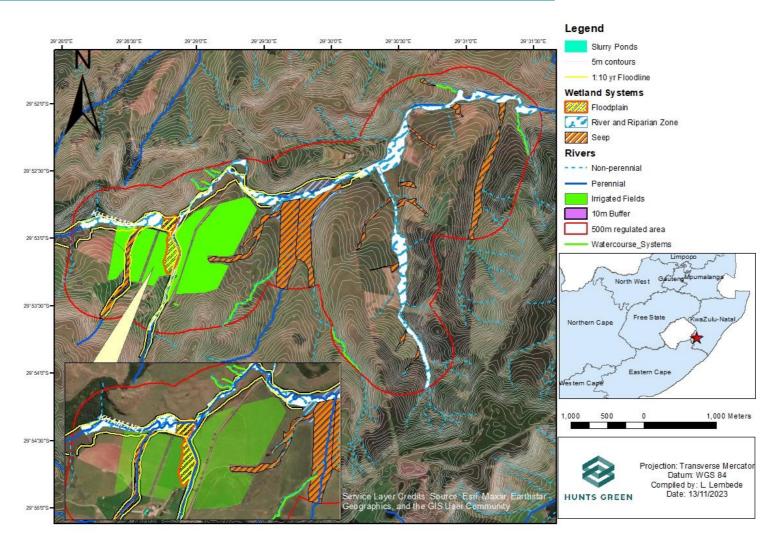
Figure 5-1: Potential sources, pathways and receptors

- Contaminant Sources:
 - Slurry water
 - Dam Construction (i.e. increased turbidity)
- Contaminant pathways:
 - Aquifers these are rock units or open faults and fractures within rock units that are sufficiently permeable (effectively porous) to allow water flow;
- Receptors:
 - These include the groundwater users, streams and natural ecosystems that depend on the groundwater.

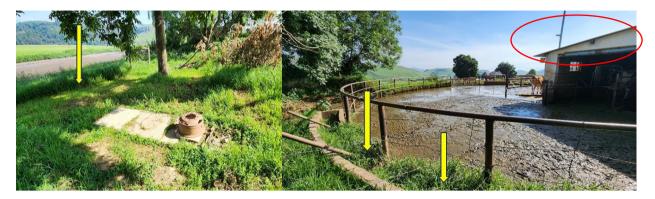
Figure 6-1: Trenches Conveying Sludge from Dairy Area to the Slurry Dams

It is recommended that the trench and pipe used to convey the slurry are always kept clear and free of litter and substances that may cause blockages and potentially reduce the effectiveness of the conveyance of slurry. It was noted that the trench is grassed, it is also recommended that the grass cover is always maintained to prevent erosion and sedimentation build up in the slurry dams. Additionally, depending on the needs of the farmer, the shed area in the dairy farm may be fitted with gutters and downpipes (see highlighted area in Figure 6-1) for rainwater harvesting in a storage tank to increase water availability for on site use. It is further recommended that if there is an expansion of the herd size in future, which would increase inputs into the slurry dams and spillages occur more frequently, the storage capacity should be evaluated to ensure that the impacts of excess nutrient rich water remains minimal, with no significant impacts to the environment and downstream water users. To ensure compliance with the National Water Act (36 of 1998) for disposal of waste by irrigation, no irrigation should take place within 100 m of a watercourse.

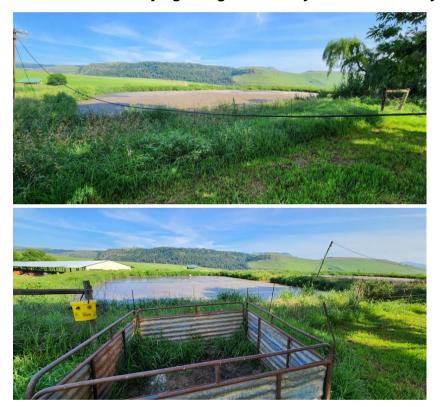
Figure 6-2: Sludge Dams with Solids and Liquids
